ErOsion Control Quick Sheet

Sediment Trap

ErOsion Control Specifications

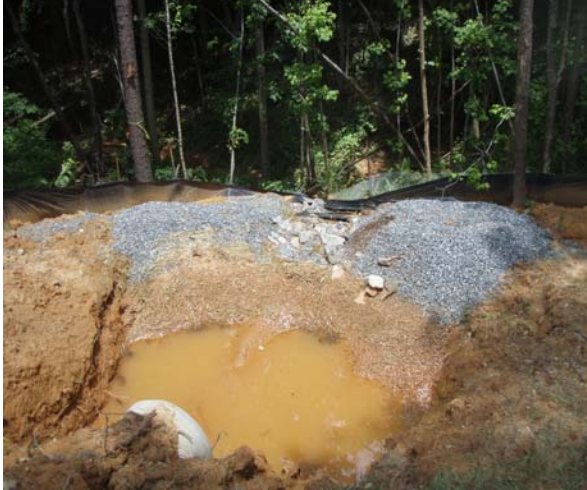
BAD: Spillway is clogged with debris. Water is pooling and not draining properly. Steep sidewalls that are unprotected can cause a failure. Baffles are absent.

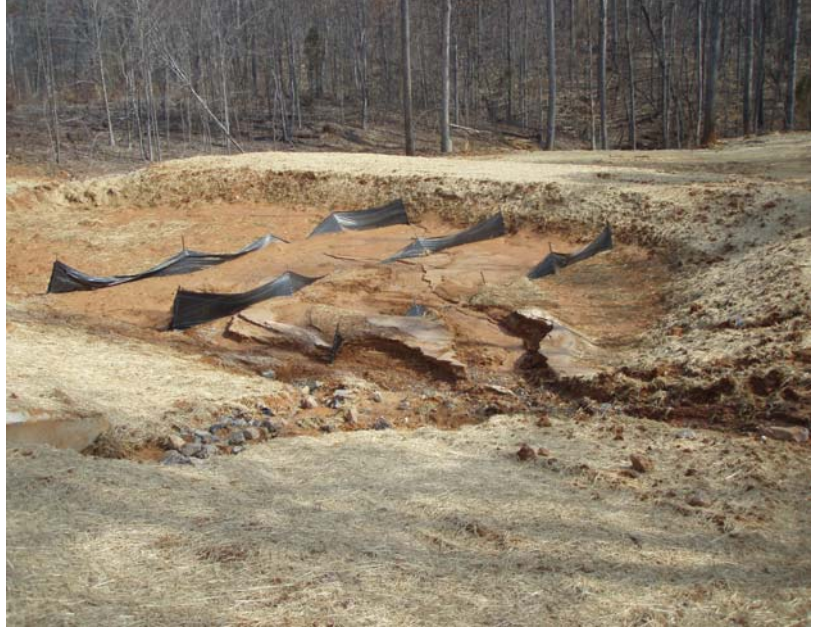
Sediment Basin

BAD: Unmaintained, with large accumulation of sediment in the basin. No vegetation on the side walls. Holds water and does not dewater properly, because dewatering structure is damaged. Baffles are overwhelmed.

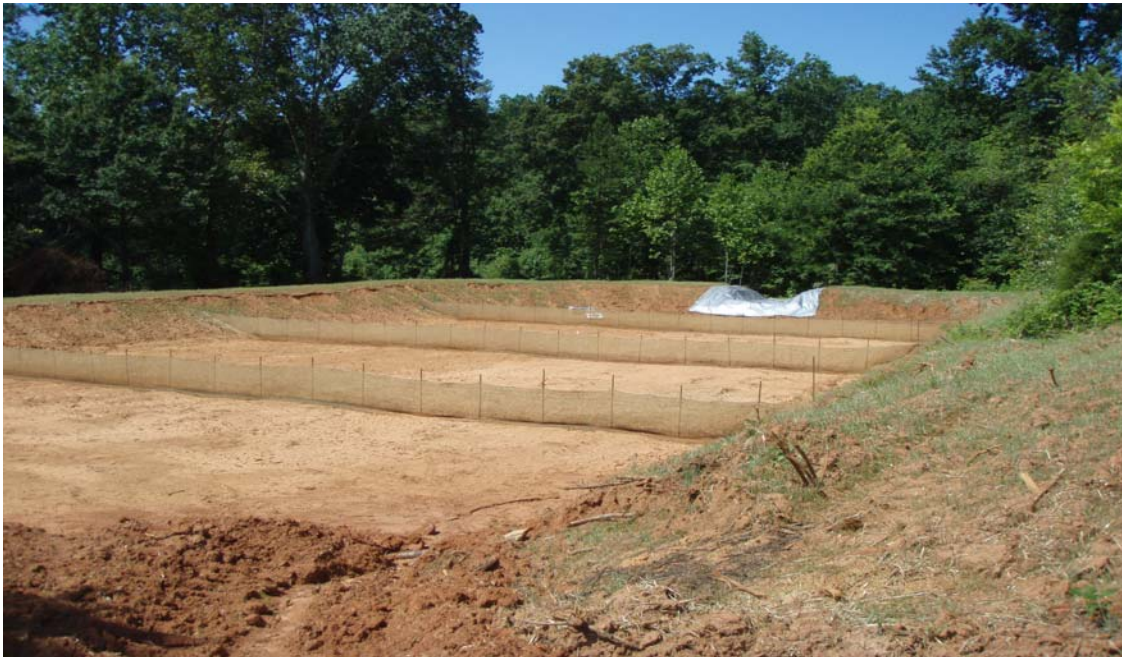
GOOD: Large flat bottom with shallow slopes that are vegetated on the backside. These structures have baffles between the inlet and the dewater mechanism and spillway. Baffle and spillways are in good working order. Dewaterers are within the design manual specifications. : Has the proper side slopes (2:1 or flatter). It is maintained and cleaned out as needed. Spillway is lower than the sidewalls of the trap. Filter fabric is under the spillway and spillway has clean stone, free of debris and sediment build up. Backside of the slopes are vegetated.

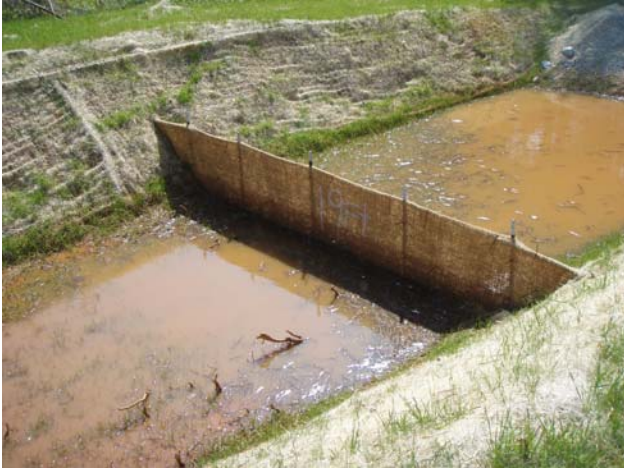
Porous Baffles

GOOD: Baffles need to be porous, and not solid like silt fence. Coir matting, Coir blanket, and straw wattles are good examples. Baffles are anchored into the side slopes of the Basins.

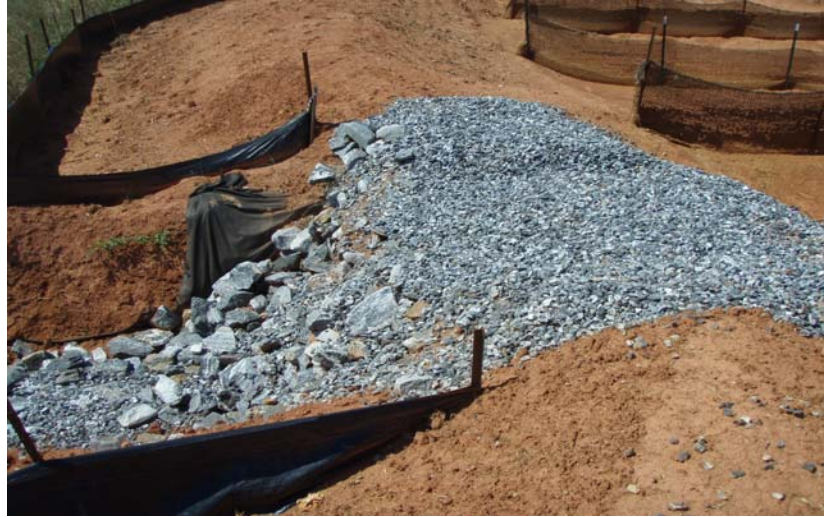
Emergency Spillway

GOOD: Clean wash stone with no debris or mud clogging the stone. Has filter fabric under the stone and on the sides. Rip rap stone behind the wash stone with a clean rip rap apron at the bottom. Spillway is lower than the side walls of the basin or trap.

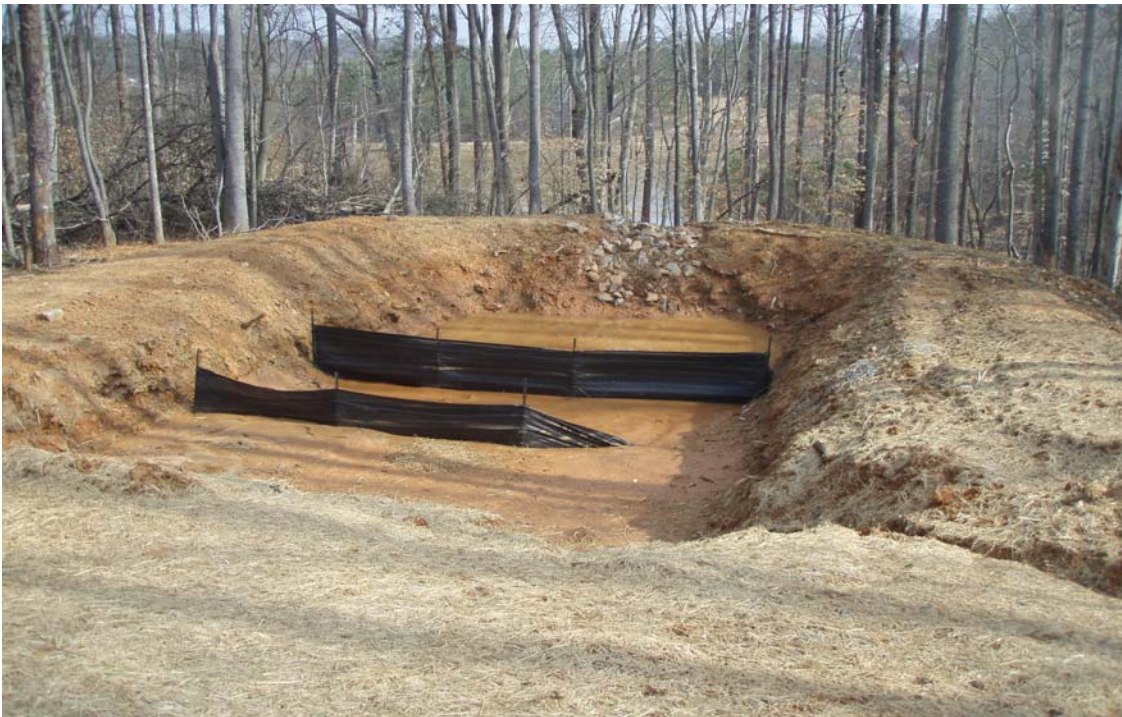
BAD: Baffle knocked over. Flow going around baffles eroding slopes of the basin. Baffles having excessive debris and sediment limits the measures functional capacity. Debris and unmaintained stone causes the erosion control measure to not dewater properly. Lack of fabric has caused the stone to settle and/or become undermined which will cause a failure over time. The lack of an apron on the exit side can cause scouring on the side walls and rutting out at the base of the spillway. This can also cause the spillway to undermine and fail.

NOTE: It is good to clean out the debris from the wash stone on the face of the spillway after each rain event. This will make the overall maintenance for the basin or trap easier and allow the measure to function longer.

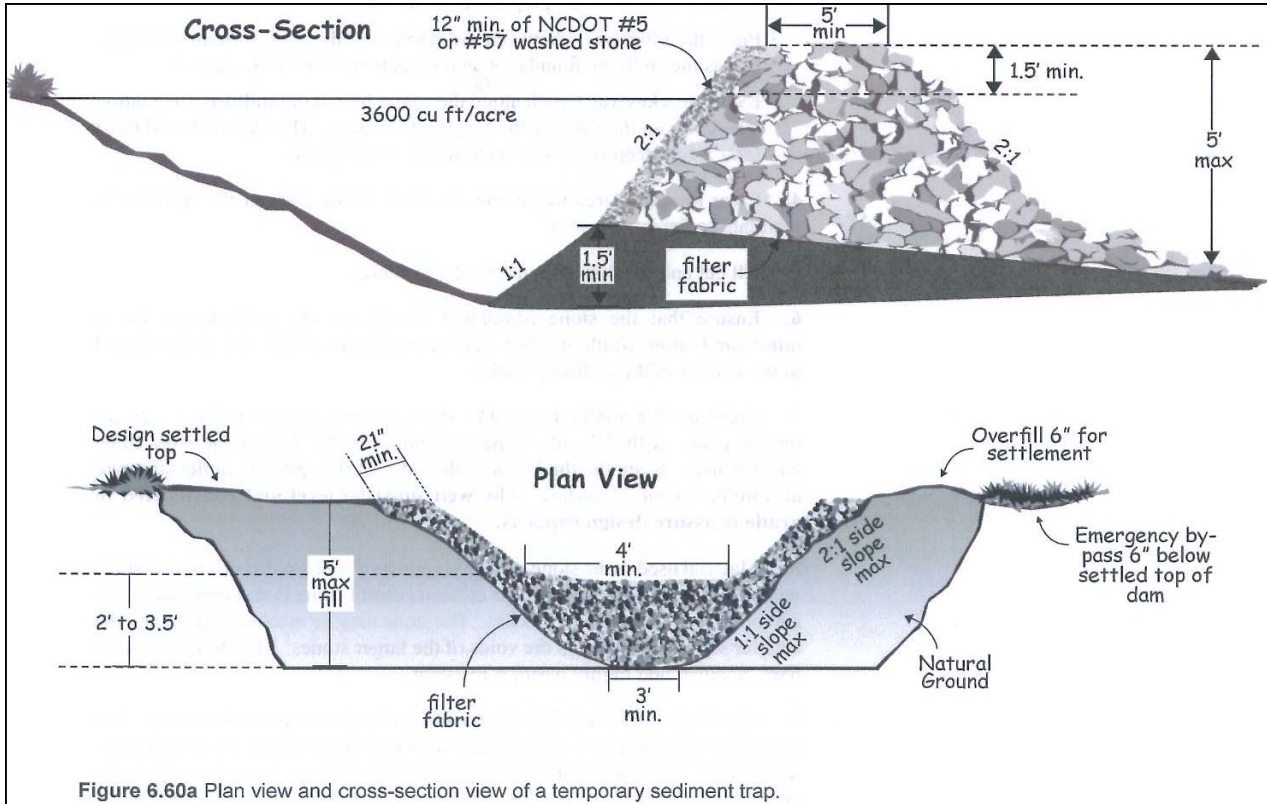
Figure 6.60a Plan view and cross-section view of a temporary sediment trap.

Sediment Trap Design Criteria
based on the NC Erosion and Sediment Control Planning and Design Manual 6.60

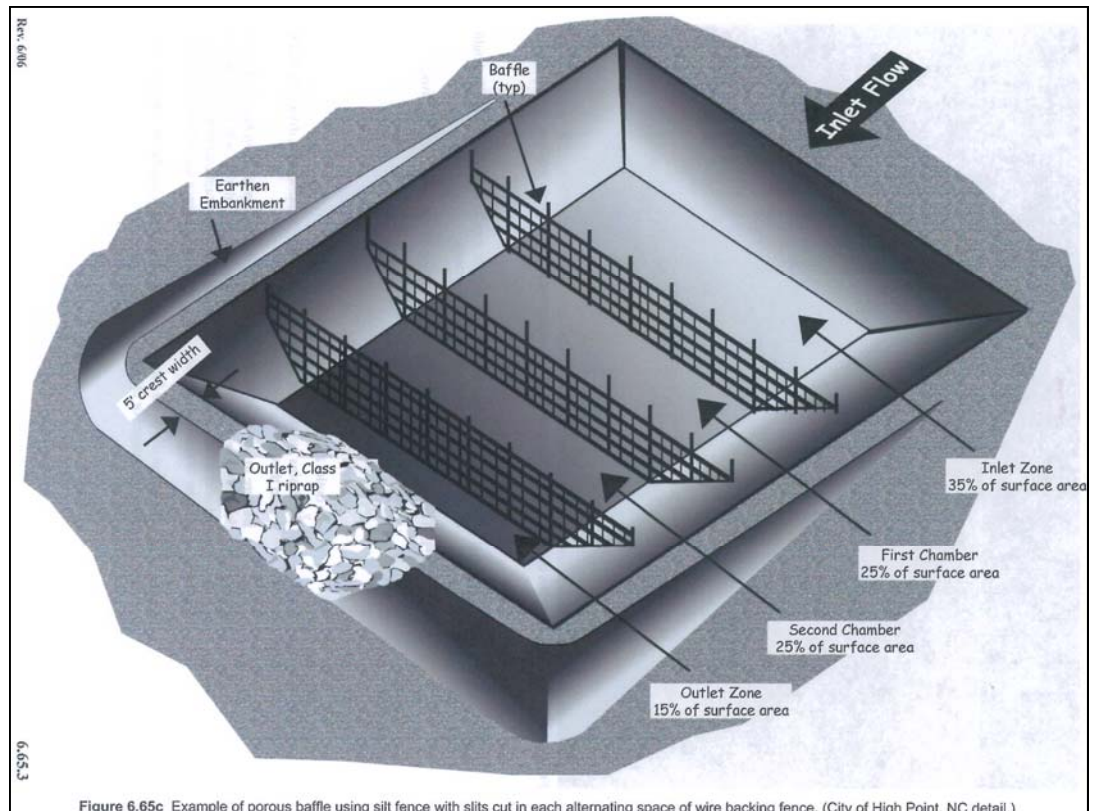
Porous Baffle Design Criteria
based on the NC Erosion and Sediment Control Planning and Design Manual 6.65

Figure 6.65c Example of porous baffle using silt fence with slits cut in each alternating space of wire backing fence. (City of High Point, NC detail.)

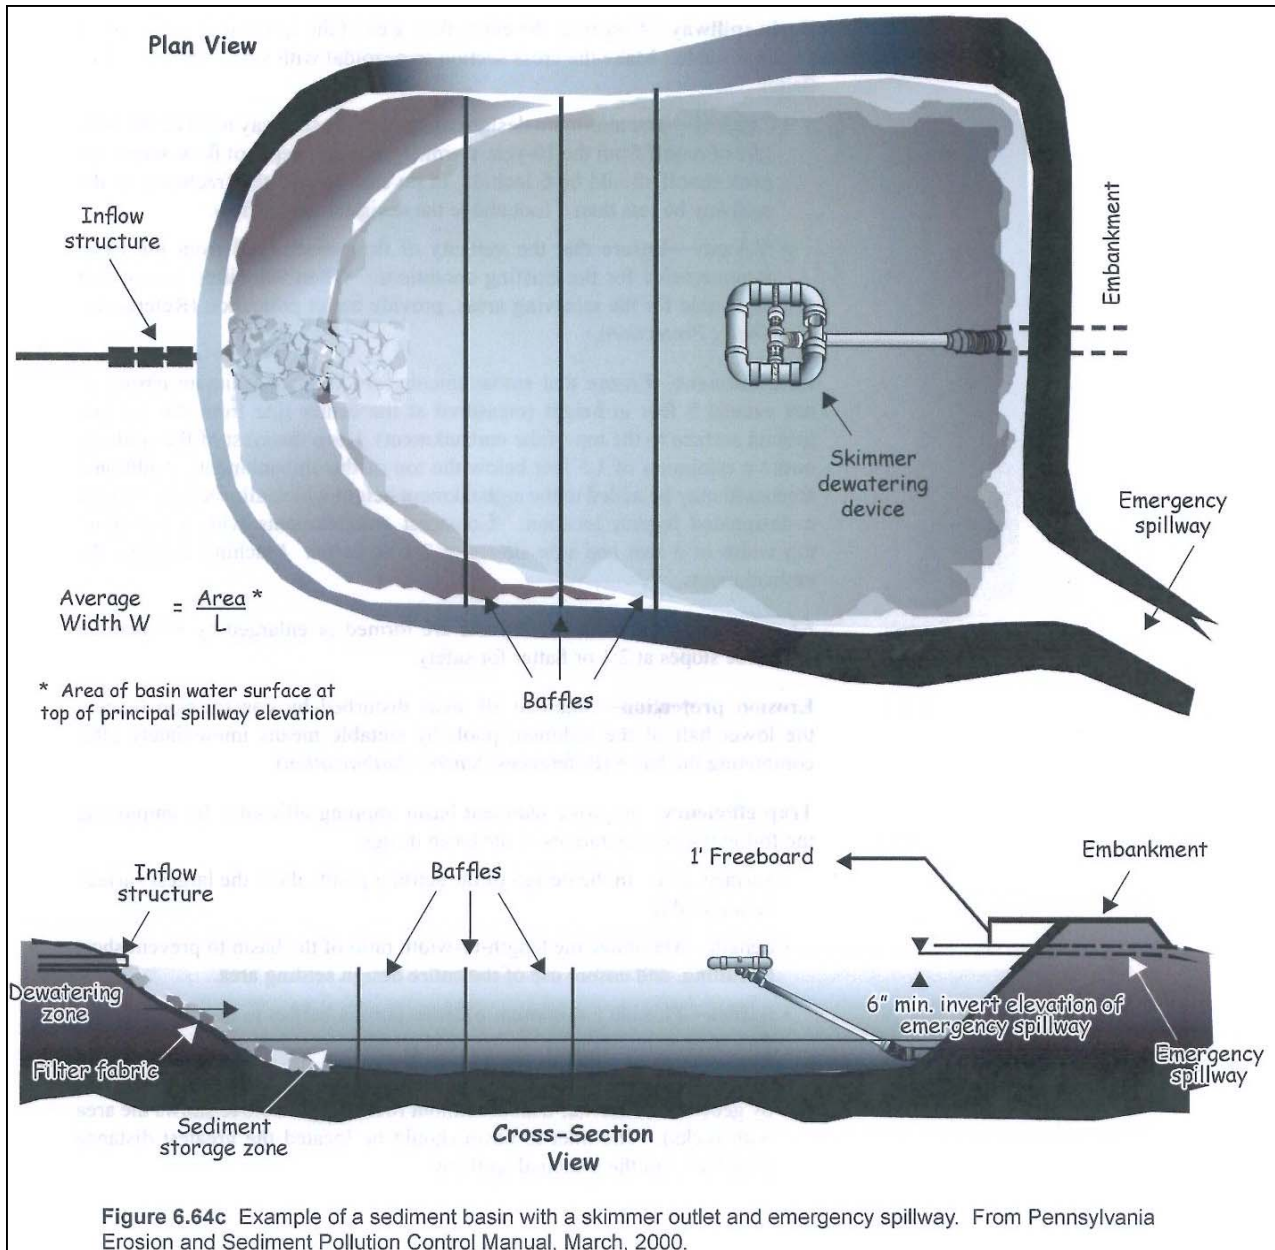
Sediment Basin Design Criteria based on the NC Erosion and Sediment Control Planning and Design Manual 6.61 (Skimmer Basin Design Criteria pictured above is found 6.64)
